PM Paladin/FAASV Newsletter

The purpose of this Newsletter is to keep the Paladin/FAASV using units and their maintenance support organizations apprised of technical information and/or lessons learned on the M109A6, Paladin and the M992A2, FAASV that may not otherwise be explained in Technical Manuals. Previous newsletters may be found at the Website indicated at the top of this page. You may also contact the Program Office by E-mail by sending a message to palsdc@pica.army.mil.

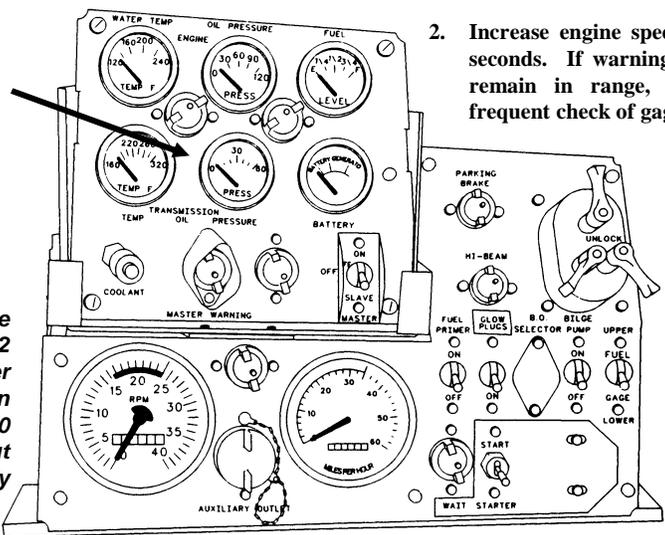
DRIVER'S INSTRUMENT PANELS

Paladin and FAASV master warning lights monitor four very important drive train functions...namely, transmission and engine temperature and pressure measurements. It's purpose is to provide an alert whenever potentially damaging conditions exist. However, at idle rpm (550-600) and while shifting in forward and reverse gear, the master warning lights may come on (steering column light not shown). This issue has been investigated. Due to transmission characteristics, very low transmission oil pressure is available at engine idle rpm. With increased engine rpm which results in higher pressure (10 psi at 1,000 rpm), the master warning lights go out. Due to safety

Master Warning Lights may come on at idle rpm and/or while shifting gear. Follow steps 1 & 2 before notifying maintenance.

Note - If, at anytime during step 1 & 2 procedures, the master warning lights come on or gages fall out of TM-10 operating range ... shut engine down and notify maintenance

reason, it has been decided not to lower the current setting of the transmission pressure switch. When master warning lights come on under the pre-described conditions, increase the engine rpm to 1,000 for 3 – 5 seconds, and 1) Check engine and transmission pressure and temperature gages - if gages read in operating range IAW TM-10, 2) The master warning lights go out, a fault does not exist. Continue operation with frequent observation of gages and master warning lights. **Important:** *If, at any time during steps 1 & 2, the master warning lights come on or gages read out of TM-10 operating range, engine should be shut-down and maintenance personnel notified.*

1. Check Engine and Transmission Pressure & Temp. If both are in TM-10 operating range, and Master Warning Lights are on at engine idle...
2. Increase engine speed to 1000 rpm for 3 - 5 seconds. If warning lights go out, and gages remain in range, continue operation with frequent check of gages.

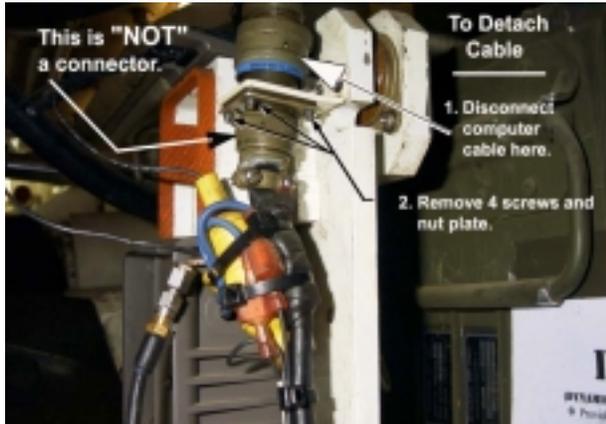
PHOTO 1. PLGR Data Cable Mounted

A number of PLGR data cables have been severely damaged when attempts were made to incorrectly disconnect the cable from its mount. Mistakes were driven by “appearance” because - “it looks like a connector”, and TM procedures (TM 9-2350-314-20-2-2, para 22-11a) that did not address specific data cable disconnect instructions. *Illustrations below are intended to illustrate damage and provide interim guidance while TM procedures are updated.* To disconnect PLGR Data Cable ... 1) Disconnect Computer Cable. 2) Remove 4 screws and Nut Plate (see Photo 1).

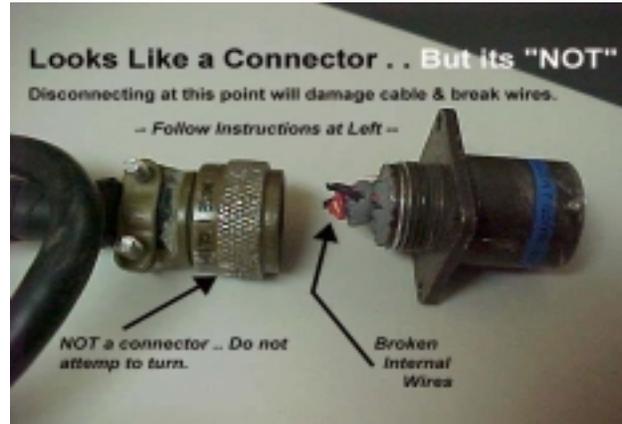
PHOTO 2. Damaged PLGR Cable Assembly when improperly disconnected

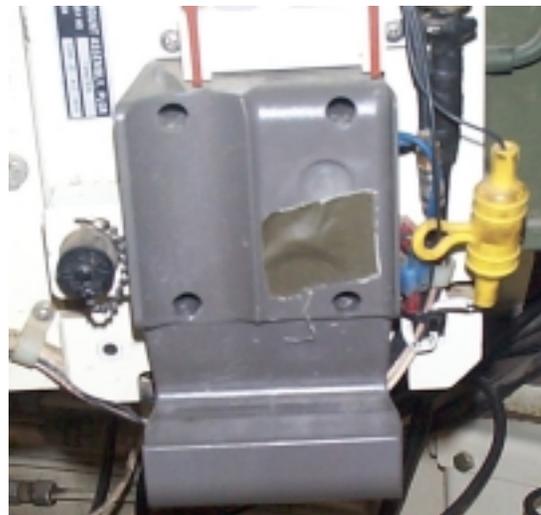
The M109A6 Paladin/FAASV Paladin's Precision Lightweight GPS Receivers (PLGR) mount has experienced problems in the field. It has been reported that many of the PLGR mounts have been experiencing intermittent power problems. While mounted within the Paladin PLGR mount, NSN 5340-01-417-1874, the PLGR often loses power and has to be reseated within the mount, often several times, before the problem is solved.

Temporary, quick, “fixes” have been utilized by the field personnel to continually receive power to the PLGR. These actions include permanently depressing the mount’s switch with tape and electrically bypassing the switch by shorting the input wires together (see photo).

Various sites have reported these failures and the use of such bypass methods. While taping or short-circuiting the mount temporarily solves the problem, this practice can lead to far more severe problems/failures. Maintaining constant power to the mount when the PLGR is removed can lead to several equipment failures. This practice can lead to permanent, irreparable damage to the cables and DRUH. At a minimum this can cause the in-line fuse to be blown.

PHOTO 1. Paladin modified PLGR mount with switch permanently depressed with tape, shown above.

If a bypass method is to be used, the following guidelines should be followed. Rather than applying tape to the mount, apply something to the PLGR that will depress the switch when mounted. The switch should never be depressed when the PLGR is not mounted with the power cable attached. The problem is currently under investigation to determine more permanent corrective measures. Occurrence of intermittent power failures should be reported to Mr. ***** at (***) ***_****. It is important to emphasize that the PLGR will not be powered when removed from the mount. Loss of power when the PLGR is removed is not a failure.

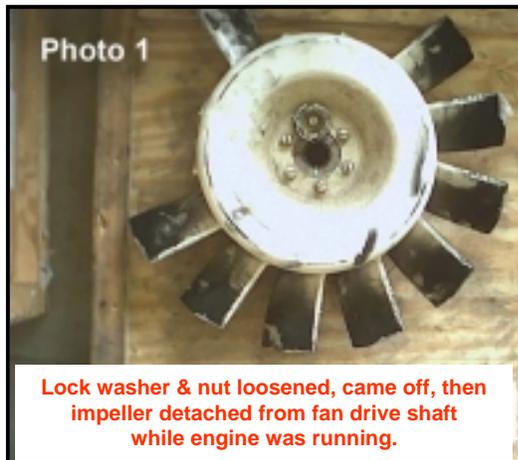
Checking cooling fan impeller fasteners is now included in Paladin's Semiannual PMCS. TM 9-2350-314-20-1-1, Feb 1999 w/C1, Table 2-1, Item 7, provides for checks of loose or missing impeller hardware and rates the vehicle "NOT FULLY MISSION CAPABLE" if either condition is found. A recent occurrence emphasizes the importance, not only of the inspection, but also correction of identified deficiencies. Photo 1 illustrates a damaged cooling fan impeller that detached from its fan drive with the engine running. *Note: FAASV's PMCS procedures are being updated.*

Prevent This From Happening To Your Paladin or FAASV

Avoid occurrence (1) Be sure keyed washer's outside tab is securely engaged into round nut slot. (2) Then, by hand, attempt to rotate the round nut left and right .. *there should be no movement (i.e., round nut/washer/shaft should move together)*. If any movement is found, keyed washer and round nut should be replaced (*never* reuse a keyed washer). (3) After installing a new keyed washer, *specific torque* must be applied to the round nut (65-75 lb-ft) using a torque wrench and spanner socket (PN 12268253, NSN 5120-01-2558-8232). **DO NOT USE A SCREWDRIVER AND HAMMER** to tighten the round nut. Torque cannot be measured using this method and the keyed washer's inside diameter tab could be damaged ... use a torque wrench and spanner socket.

Task instructions: Paladin - TM 9-2350-314-34-1, Para 6-1. FAASV - TM 9-2350-293-34, Para 5-5.

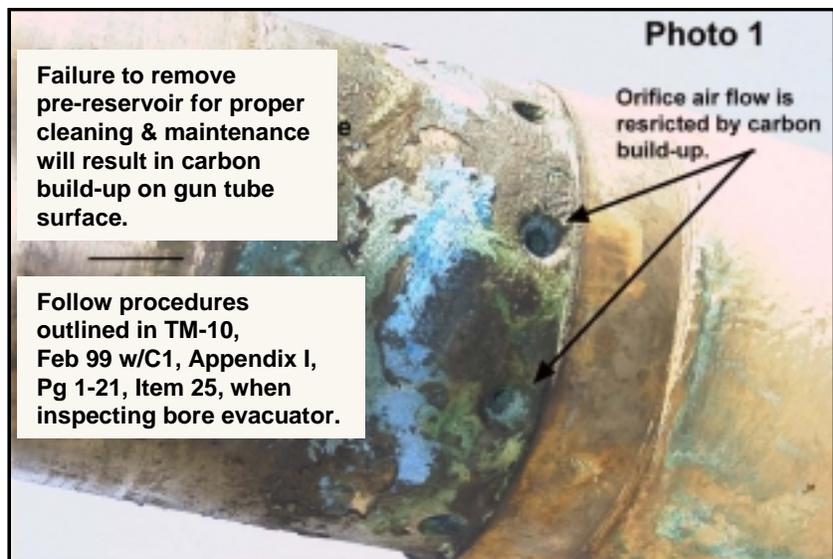
A. M109A5/A6 SELF-PROPELLED HOWITZER: RECENTLY THERE HAVE BEEN TWO CARBON MONOXIDE (CO) INCIDENTS DURING LIVE FIRINGS OF M109A6 SPH, RESULTING IN INJURIES TO CREW. EXPOSURE TO AIR CONTAMINATED WITH CARBON MONOXIDE MAY PRODUCE ONE OR MORE OF THESE SYMPTOMS: NAUSEA, HEADACHE, DIZZINESS, APPARENT DROWSINESS, LOSS OF MUSCULAR CONTROL, AND COMA. PERMANENT BRAIN DAMAGE AND DEATH CAN RESULT FROM SEVERE EXPOSURE.

B. INVESTIGATION HAS IDENTIFIED MISSING /DAMAGED BORE EVACUATOR O-RINGS, EVACUATOR BALLS, AND RING VALVES AS CONTRIBUTING FACTORS.

C. THIS ALLOWED EXCESSIVE SMOKE AND CO TO ENTER THE SPH TURRET AND OVER EXPOSE CREW.

Observations and data indicate that, typically, pre-reservoir maintenance is omitted when "after-firing" gun tube cleaning is performed (Photo 1). And, a significant amount of live fire is conducted with both bore evacuator and pre-reservoirs in less than serviceable condition ("O" rings missing, chipped, incorrectly installed, etc.). Based on SOUM information above, all gun tube cleaning should focus considerable attention on bore evacuator and pre-reservoir surfaces, orifices, and associated components. Instructions found in TM -10, Feb 99 w/C1, Appendix I, Item 25 are an excellent tool for this purpose. For convenience and illustration the instructions are reprinted below.

After firing, separate main reservoir (43) and move preresevoir (44) forward toward muzzle. Refer to para 3-8.8. Slide valve ring (45) forward and remove nine evacuator ball valves (46). The balls should fall out. Thoroughly clean evacuator ball valves (46), nine preresevoir orifices (46.1), 10 evacuator orifices (47) and tube threads (48) with CLP, using brush (11686340). Clean three metering holes (49) with CLP, using brush (8432358). Apply light coat of GMD or GGP to balls, ring, and unpainted tube surfaces before assembling. Inspect O-rings (preformed packings) (50 and 51), on inner and outer grooves of preresevoir (44) and (52) on inside groove main reservoir (43) for damage or missing. Inspect for gas wash and soot past O-rings. If any of these conditions exist, notify unit maintenance for replacement of O-rings. Remove any accumulation of soot from inside main reservoir. For nonfiring periods, bore evacuator and evacuator balls are cleaned and lubricated monthly.

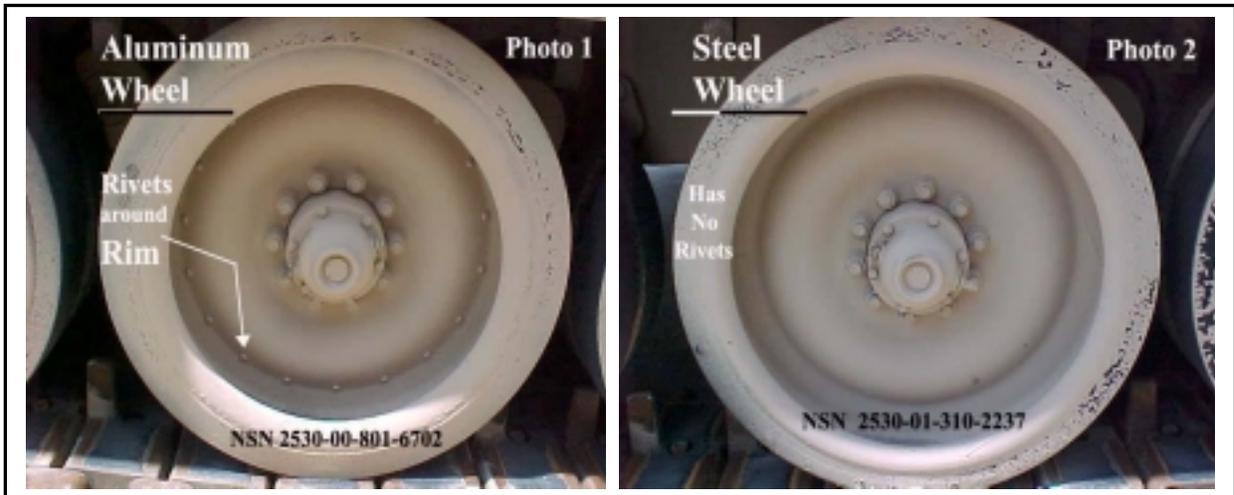
A considerable number of Paladins and FAASVs have been observed with steel and aluminum road wheels mounted on the same hub. This practice should be discontinued and hubs that have “mixed” road wheels mounted should be brought into compliance. Steel or Aluminum wheels are permitted, *but not on the same hub*. To be compliant, both road wheels on the same hub must be of the same material. The single, most obvious, difference between steel and aluminum wheels are rivets in the aluminum wheel ... steel wheels have no rivets.

Note: Use this characteristic to also identify inner wheel type.
